Fracture and Gully Formation in Glacial Fill: Field Observations at the WillowCreek Landfill, Portage County, Ohio, with Implications to Historic Earthen Dam Failure Sites in the US¹

JULIE WEATHERINGTON-RICE AND GEORGE F. HALL, Bennett & Williams Environmental Consultants Inc., Columbus, OH, 43231; The Ohio State University, School of Environment and Natural Resources, Columbus, OH 43210

OHIO J SCI 106 (2):27-34, 2006

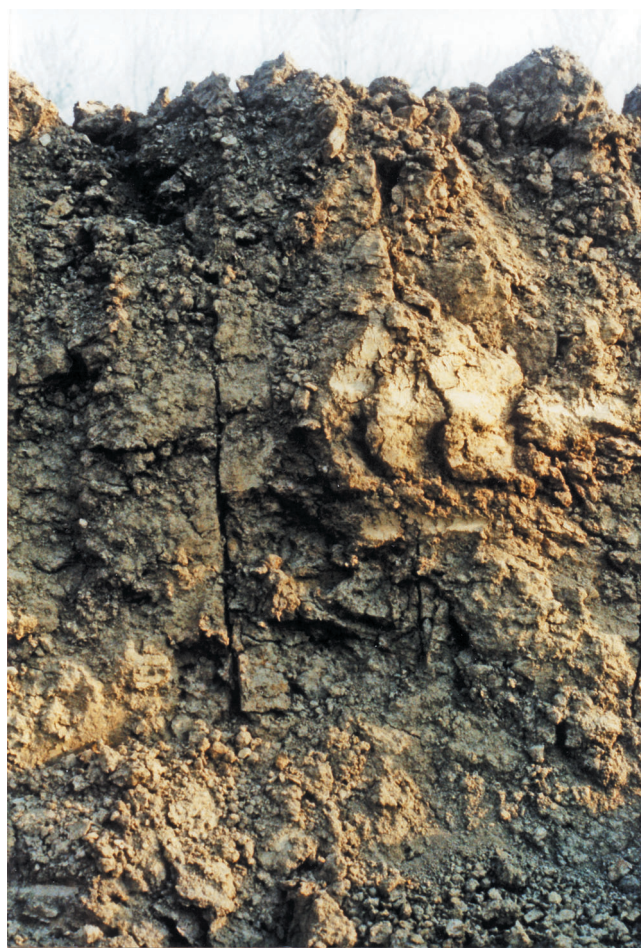
The photographs taken of these stockpiles during the several years of field activity on the site document extensive fractures and gullies that had been formed in a very short period of time. Figures 2 through 4 document the newly formed fractures in the fill material. Figure 2 shows the fill at the initial staging area where glacial tills and their associated soils had been stockpiled for approximately five years or less. This photograph was taken at the top of the first staging pile, which rose to a high point of 20 m above the surrounding ground surface. This upper portion represents only one to two years of placement of fill. Figure 3 shows the fill after being pre-sorted at the northwest pod location where the stockpile had been in place for only two years. Figure 4 shows the fill used as a pre-RCRA final cap, at this location the cap had been in place for approximately five years. Additional photographs from this site can be seen in Chapter 2 of Weatherington-Rice (2003).

FIGURE 2. Vertical fractures in top dump lifts, initial staging area. Note fractures appear to form across variations in texture and color within the stockpiled deposit. Cut approximately 2.0 m high. These newly formed fracture faces are not stained and/or do not have secondary mineral depositions. (Photo by J Weatherington-Rice)

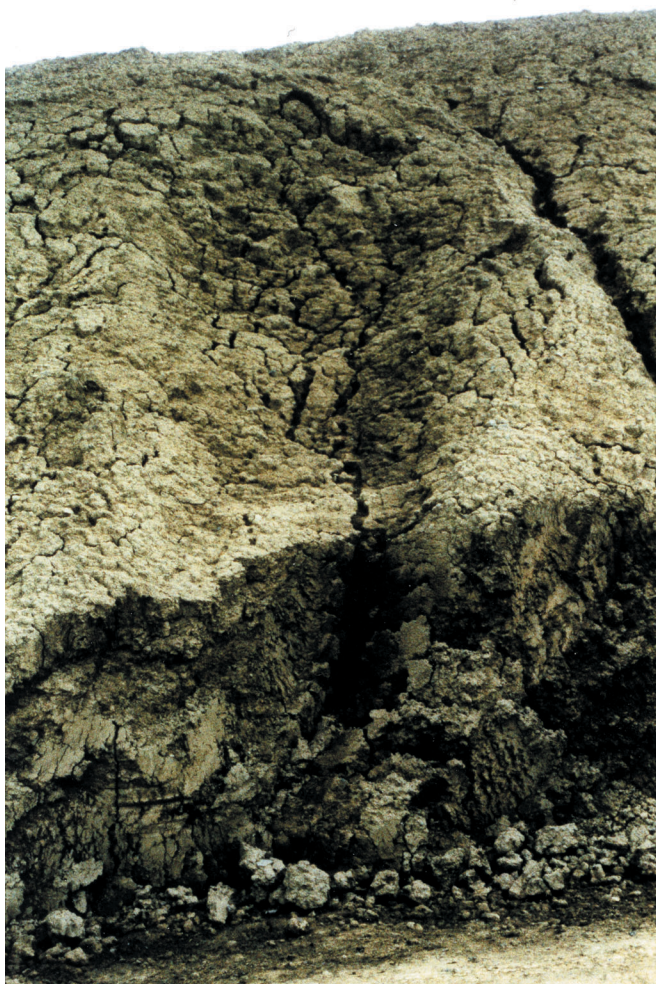
In each case, the fractures formed rapidly. The vertical fractures appear to control the surface representation of gully formation in Figure 3. There are vertical fractures with surface gully formations on top of them. There are also vertical fractures between the gully formations, but there are no gullies without vertical fractures formed underneath them. These relationships were documented in one field setting at the WillowCreek Landfill, but it has been the experience of the authors, upon reflection,

FIGURE 3. Close-up of the northwest pod stockpile. Cut side can be seen in the larger scale photo. Note the vertical fracture supporting the gully formation in the center of the picture. Cut face approximately 1.5 m high. (Photo by J Weatherington-Rice)

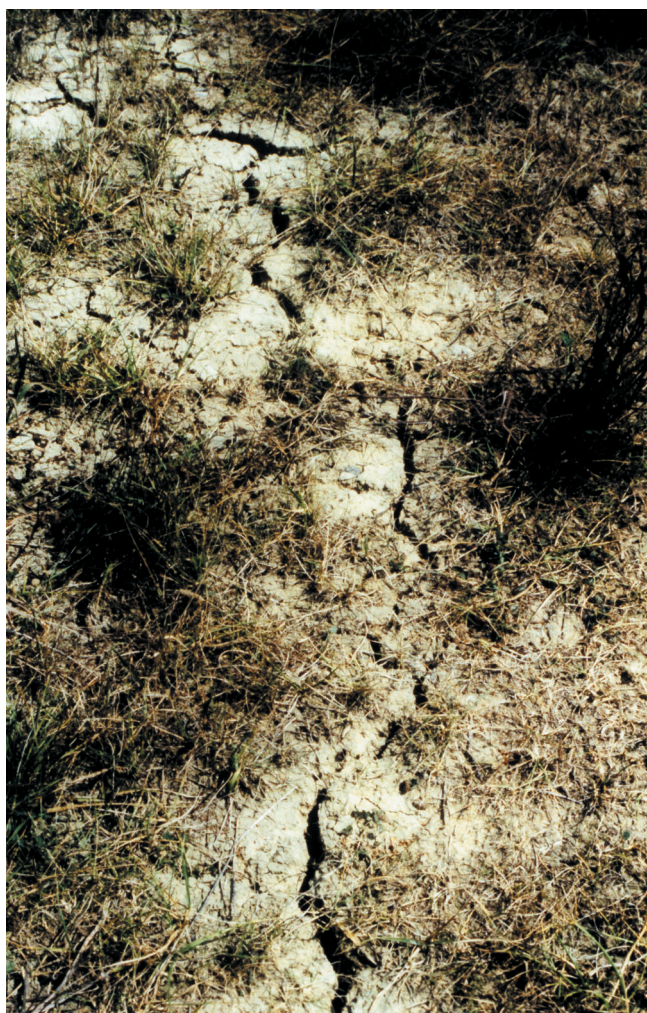
This relationship of fractures to gullies is not unlike the conditions on earthen dams noted in the southwest by Sherard and others (1963). As witnessed in the field, the fractures also contribute significantly to the migration of precipitation infiltration into the landfill and gas migration out of the underlying solid waste materials at the site (Fig. 4). This observation has been confirmed both visually and by smell.

The final landfill cap in place at this pictured location was installed before 1990 (Fig. 4). Therefore, there was no synthetic Resource Conservation and Recovery Act (RCRA, 40 CFR Parts 240-299) cap installed under the final soil and vegetative cap to prevent inflow of precipitation or the escape of landfill gases from the site. Much of the existing landfill was undergoing final closure under RCRA requirements but there were old sections as well, such as the area shown in Figure 4, which closed before RCRA was passed, so those sections remain without a synthetic underliner to the cap.

FIGURE 4. Linear- and polygonal-controlled fractures on final cap, pre-RCRA section WillowCreek Landfill. Note vegetation mostly restricted to matrix areas. Gas migration through the fractures contributes to lack of vegetative cover on the cap's surface. Cap approximately five years old at this location when photographed. Fractures were traced at least 0.5 m through the cap material by inserting a stiff survey flag wire shaft until resistance was reached. (Photo by J Weatherington-Rice)

It is exactly this desiccation phenomenon, coupled with freeze-thaw, which caused the failure of the landfill clay cap shown in Figure 4. While the initial landfill cap construction may have occurred at optimum moisture content, one annual Ohio cycle of freeze-thaw and summer drying is enough to begin to breach the emplaced clay cap. The deeply fractured pre-RCRA clay cap at WillowCreek (Fig. 4) was less than five years old when photographed.
